Comments on the 3D Printed P&R Steel Gondola

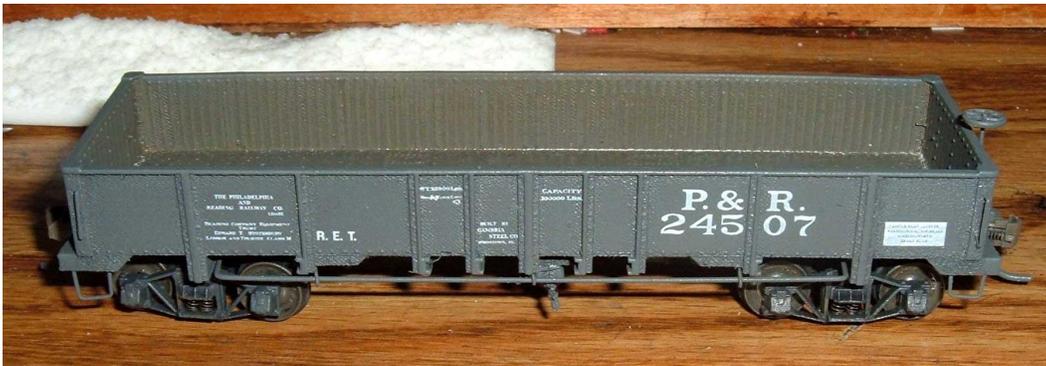
The corrugations on the inside walls of this 3D printed gondola are remnants of the support material deposited during the printing process to permit the printing of overhanging features on vertical (actually, all non-horizontal inward-leaning) surfaces. The car body was printed right side up. (If printed upside down the entire body cavity would be filled with support material, which would make it very expensive.)

Support material is deposited all the way up from the base to the feature being supported, and the body material is degraded where the two are in contact. The support material is melted and dissolved away when the part is cleaned, but the roughness in the contact areas remains.

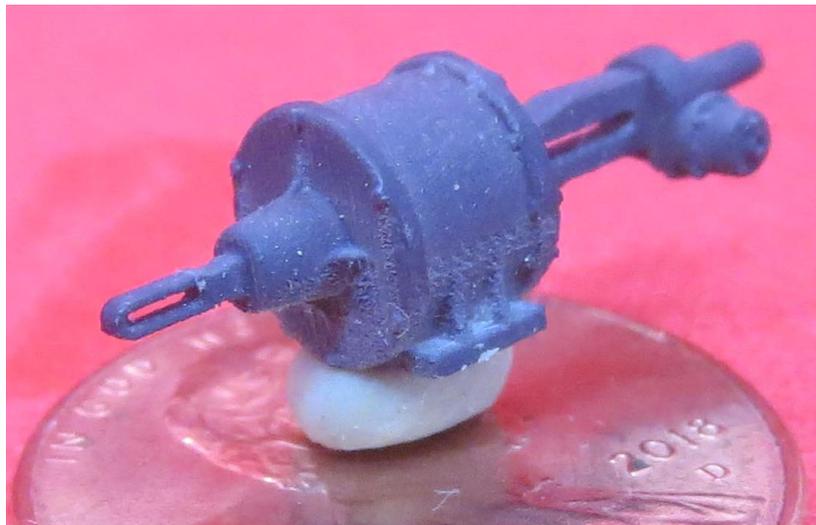
It's more of a difference in texture than in dimensions, but it can still be visually jarring especially on a small part like this HO brake cylinder. Note the roughness below the bolt heads, and on the underside of the cylinder body. Fortunately, this part will be up against the underside of the car, inset from the side, and not out in full view.

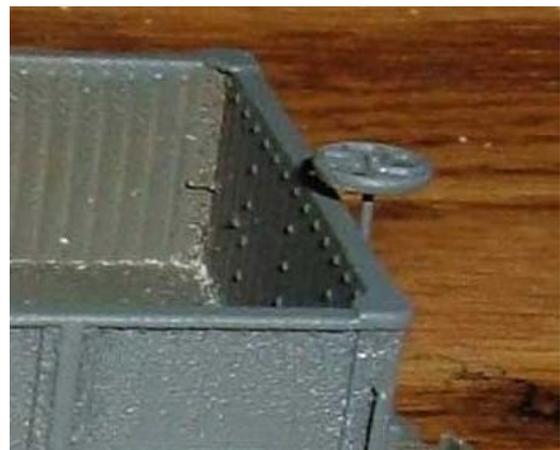
The gondola corrugations actually aren't as pronounced as they might appear. The lighting doesn't flatter the sidewall rivets or the rivets on the inner end walls show how all the rivets would look under more favorable lighting.

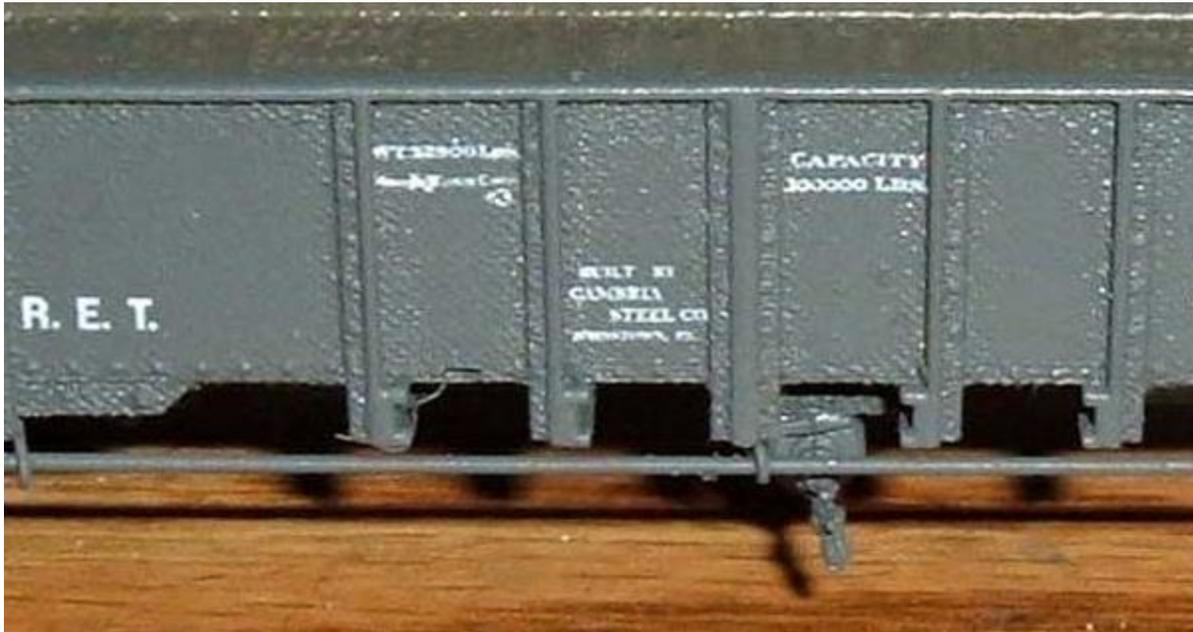
Now, you're going to ask, "Why aren't there corrugations on the outside wall if it's lit the same as the inner wall?" Simple - the bulb angle at the top of the side needed to be supported, so the entire side was coated with support material during printing. Thus it had a more uniform texture. The centers of the panels are smoother than the edges, but I don't know whether the modeler sanded them or they are "as printed". The outer surfaces of the side stakes and the ends of the channels at their bases are nice and smooth. They are in line with the outer edges of the bulb angle and didn't get coated with support material.

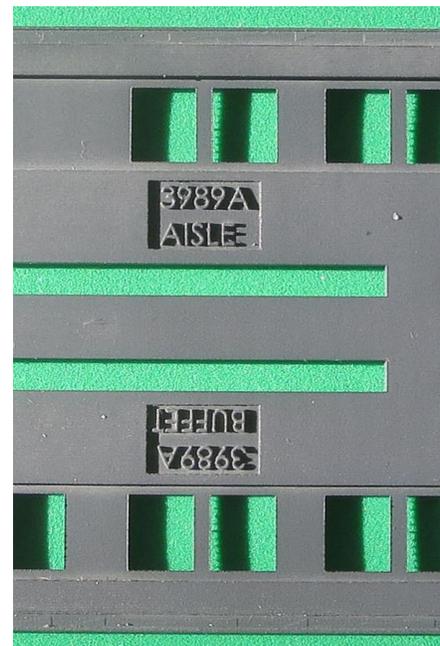
The photos of the underside and the floor of the gon in Eric's blog post show both are pretty smooth. The floor would have been printed facing up so you'd expect it to be clean. The underside would have been completely coated with support material but horizontal surfaces don't show as much degradation as vertical ones - possibly because they contact the full face of a support material layer rather than a succession of individual edges. The photo at right shows the underside of one of my Pullman 3D prints, and although it doesn't have very much "fine detail", what's there is really clean. The surfaces, which have been cleaned and primed but not sanded, are nice and smooth.

The gondola is a nice model that's very well designed. It might have been better to break it down into components that could be ganged together and printed flat. It wouldn't use any more body material, and probably less support material, and should fit in Shapeways' 7x11 footprint for the process.
